UNITED STATES COAST GUARD

REPORT OF THE INVESTIGATION INTO THE EVER FORWARD (O.N. 9850551) GROUNDING IN THE VICINITY OF CRAIGHILL CHANNEL ON MARCH 13, 2022

MISLE ACTIVITY NUMBER: 7412263

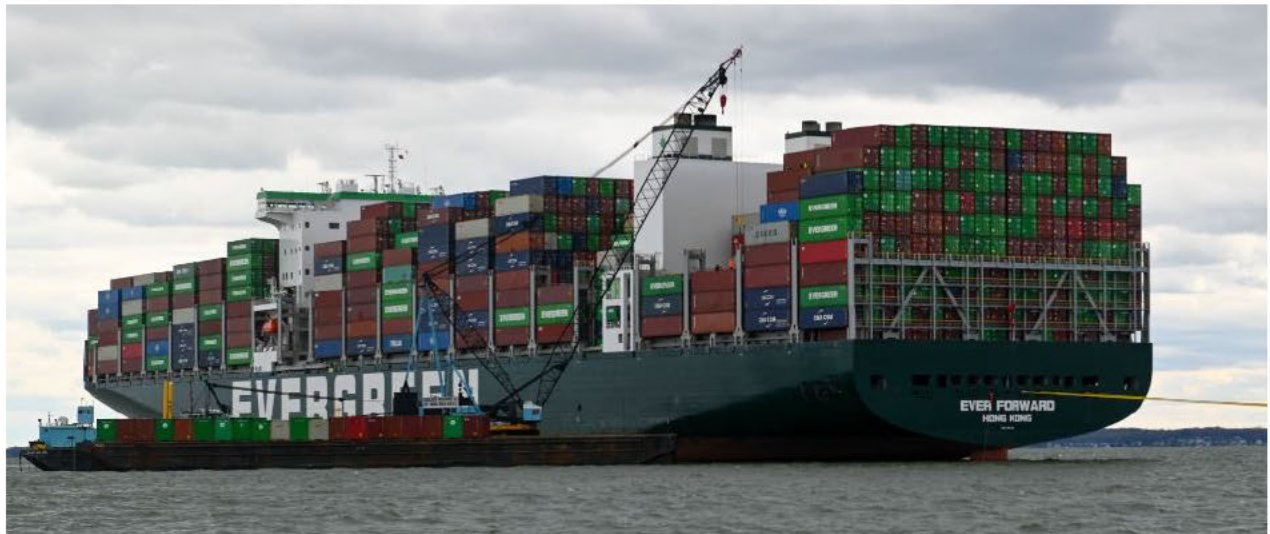
Figure 1. View from the port quarter of EVER FORWARD, aground east of the Craighill Channel.
Photograph taken April 14, 2022 by USCG.

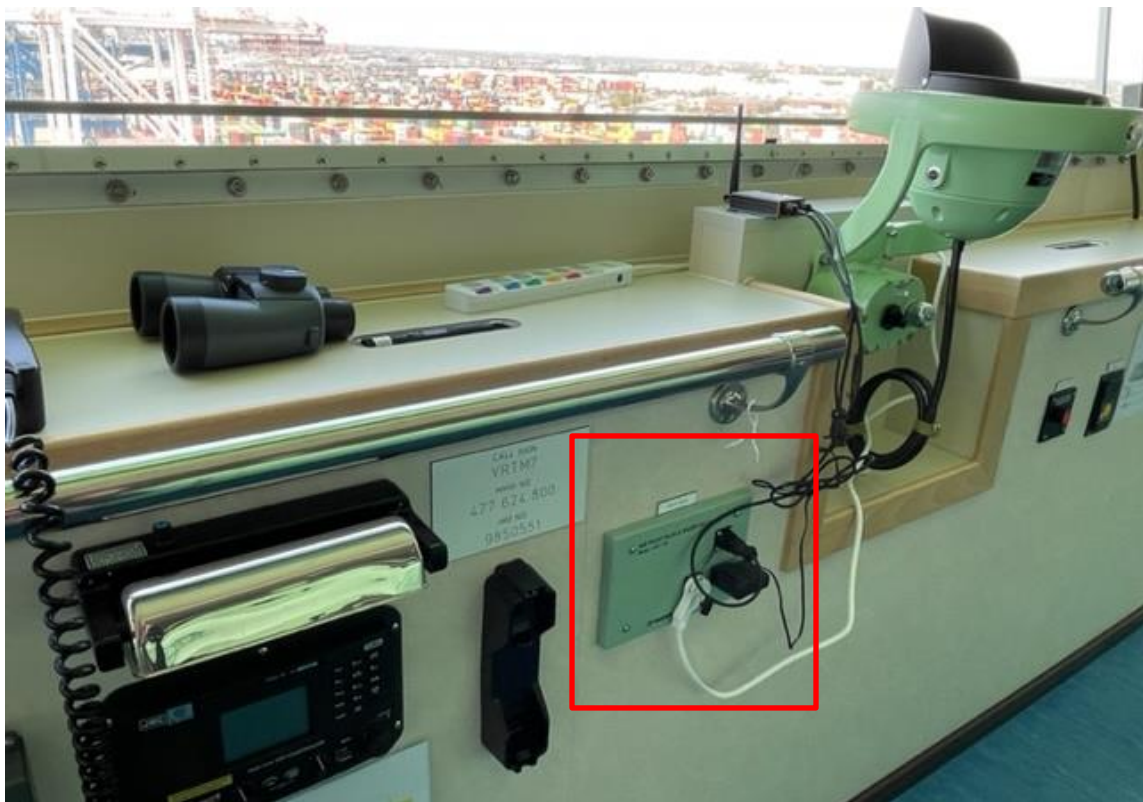
4.1.3. Pilot 1’s Portable Pilot Unit (PPU) was receiving information from the ship's pilot plug. Pilot 1’s PPU had no history of navigational discrepancies or issues.

Figure 2. The red square shows the location of EVER FORWARD’s Pilot Plug. This photograph was provided by Association of Maryland Pilots and taken in Baltimore, Maryland.

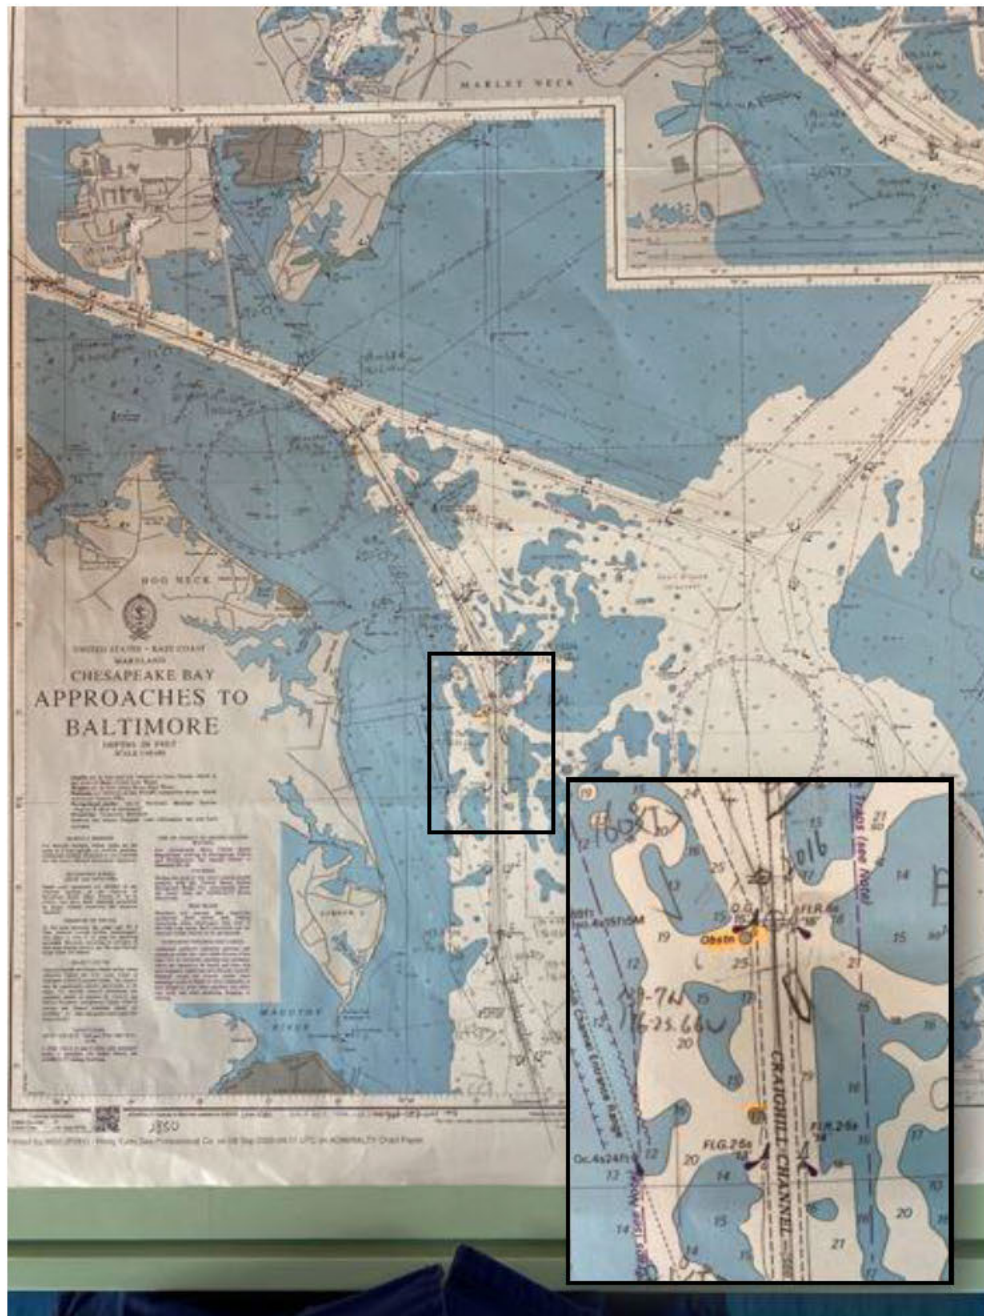
4.1.5. Pilot 1 was not aware that there were paper charts available and in use by the bridge team at the time of the transit.

Figure 3. Paper chart that was in use and on the bridge of the EVER FORWARD at the time of the grounding. The outlined inset shows a close-up of the plotted voyage plan track line and waypoints as well as the vessel location after grounding. Photograph by USCG Investigator.

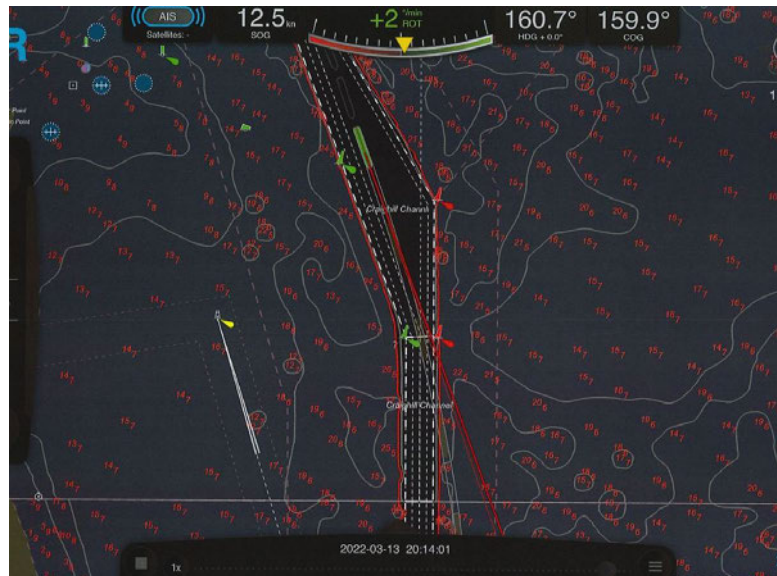
4.1.19. At 2014, Pilot 1 viewed another screen on the PPU with the intent to screenshot data from another voyage. This action stopped the recording of the active transit, and the PPU did not begin recording the active transit again until 2019, after the vessel grounded and the pilot returned to the active screen.

Figure 5. PPU screenshot just before the end of the first recording of EVER FORWARD's transit at 2014 on March 13, 2022, just prior to the grounding. Image provided by Pilot 1.

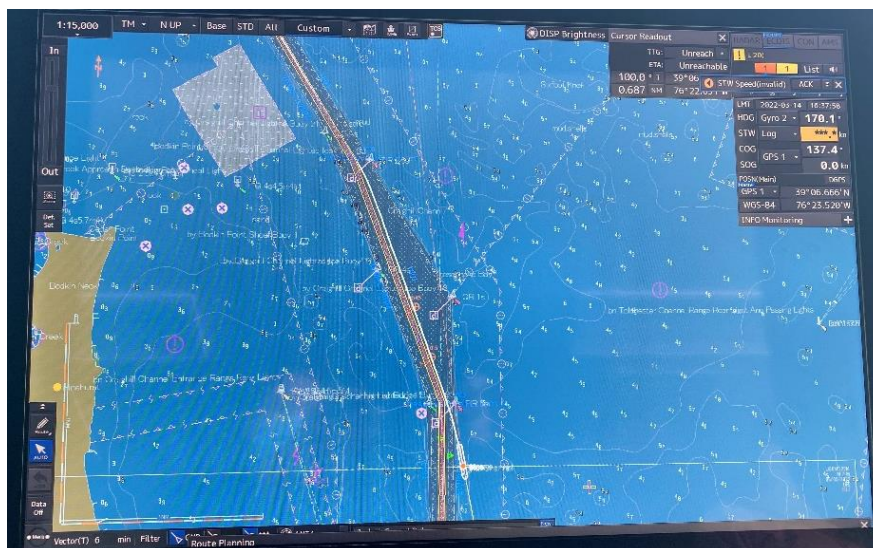
4.1.22. At 2017, the EVER FORWARD crossed the predetermined waypoint position to initiate a turn to approximately 180 degrees. No order to turn was given by Pilot 1, and the Voyage Data Recorder (VDR) showed the vessel maintained a heading of approximately 161 degrees.

Figure 6. ECDIS display of EVER FORWARD's intended voyage compared to actual track, showing the missed turn south to 180 degrees. Image obtained by USCG Investigator.

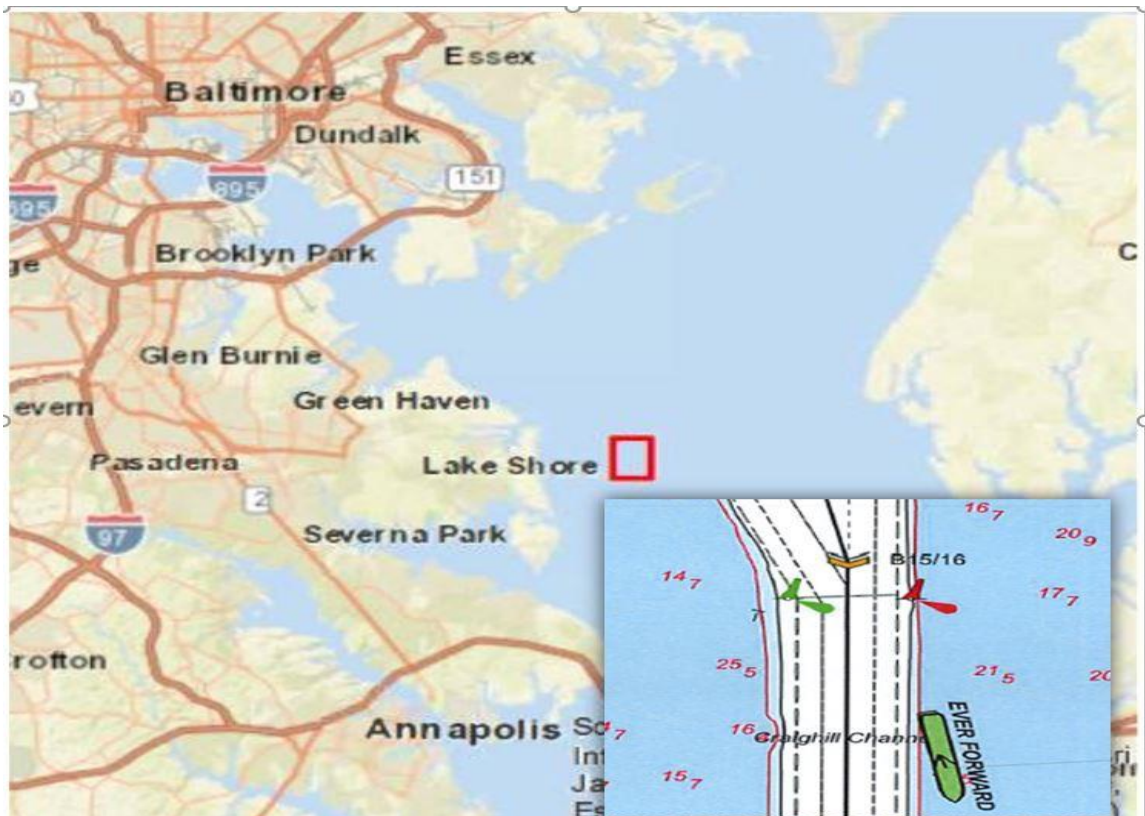
4.1.27. At 2018, the EVER FORWARD grounded outside of the Craighill Channel.

Figure 7. Red square indicates general location of grounding, south of buoy 16 outside the Craighill Channel. The inlayed image was obtained from USCG Navigation Center and obtained by USCG Investigator.

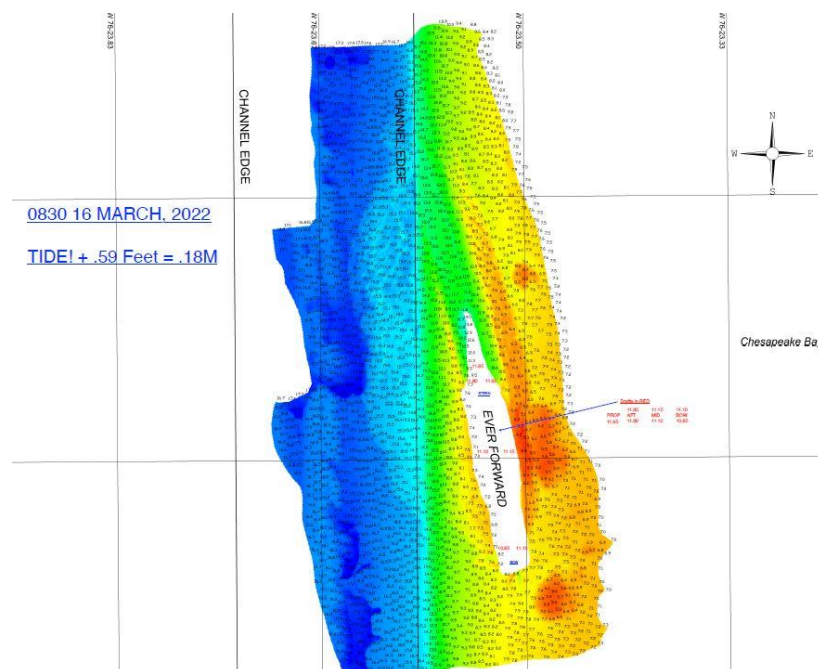
Figure 8. Multi-beam survey of EVER FORWARD grounded outside the Craighill Channel. Survey was conducted and image was produced by Donjon-SMIT LLC.

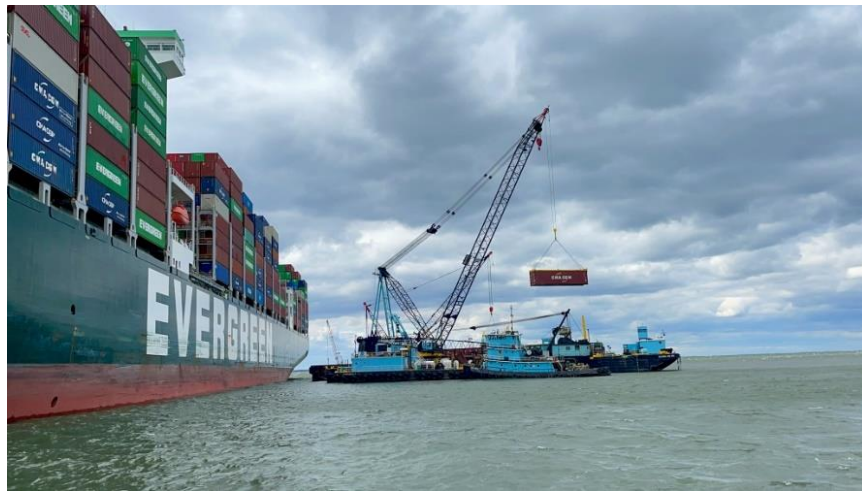
Figure 11. Crane operations on the port side of the EVER FORWARD during attempts to refloat the vessel. This photograph was provided by USCG District 5 Public Affairs.

4.2.22. On April 17, 2022 at approximately 0700, the EVER FORWARD was successfully pulled back into the channel and refloated, after dredging 206,280 cubic yards of material and the removal of 505 containers.
