Marine Investigation Preliminary Report

Contact of Containership *Dali* with the Francis Scott Key Bridge and Subsequent Bridge Collapse

Location:	Baltimore, Maryland	Accident Number:	DCA24MM031
Date and Time:	March 26, 2024 0129 local time (eastern daylight time)	IMO Number:	9697428
Ship:	<i>Dali</i> (Neo-Panamax containership)	Injuries:	8 (6 fatal)

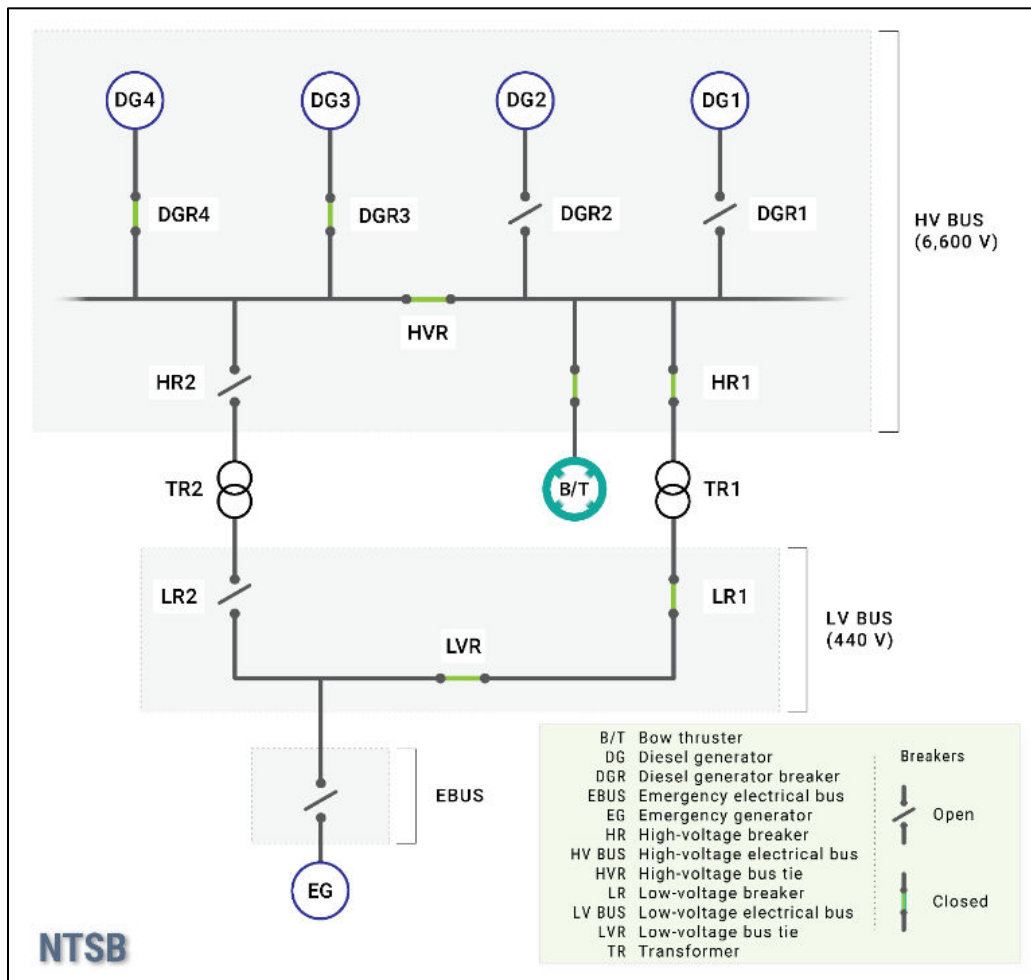
Figure 5. Simplified one-line electrical diagram of the *Dali* electrical power distribution system. Breakers shown reflect their positions at departure on March 26.

About 0125, the *Dali* was 0.6 miles—or three ship lengths—from the Key Bridge when electrical breakers (HR1 and LR1) that fed most of the vessel's equipment and lighting unexpectedly opened (tripped) (see figure 7). This caused the first blackout (loss of electrical power) to all shipboard lighting and most equipment, including the main engine cooling water pumps (which controlled engine cooling water pressure) and steering gear pumps.

- The *Dali* crew was able to restore electrical power to the vessel, but, when the ship was 0.2 miles from the bridge, a second electrical blackout occurred because DGR3 and DGR4, the breakers that connected generator nos. 3 and 4 to the HV bus, opened, causing a total loss of vessel electrical power (HV bus and LV bus). Having connected to the emergency bus by this time, the emergency generator provided electrical power to the emergency equipment continuously through the second electrical blackout.
- Generator no. 2, which had previously started automatically because it was in standby mode, connected and restored power to the HV bus via DGR2.

While recovering from this second blackout, the crew switched the bus configuration to use breakers HR1 and LR1 and the bus's associated transformer (TR1) instead of breakers HR2 and LR2, which had been in use for several months. TR1 and its associated breakers, HR1 and LR1, were in use when the ship departed on March 26.

The first in-port blackout was caused by the mechanical blocking of the online generator's exhaust gas stack. The second blackout in port was related to insufficient fuel pressure for the online generator. During both of these electrical power-loss events, the online generators' breakers (DGR2 and DGR3) to the HV bus opened before the HR2 or LR2 breakers opened. During the recovery, the crew put TR1 online to feed the LV bus because TR2 had reportedly been in use for several months.

The first vessel blackout after departure on March 26 occurred when the HR1 and LR1 breakers opened unexpectedly.

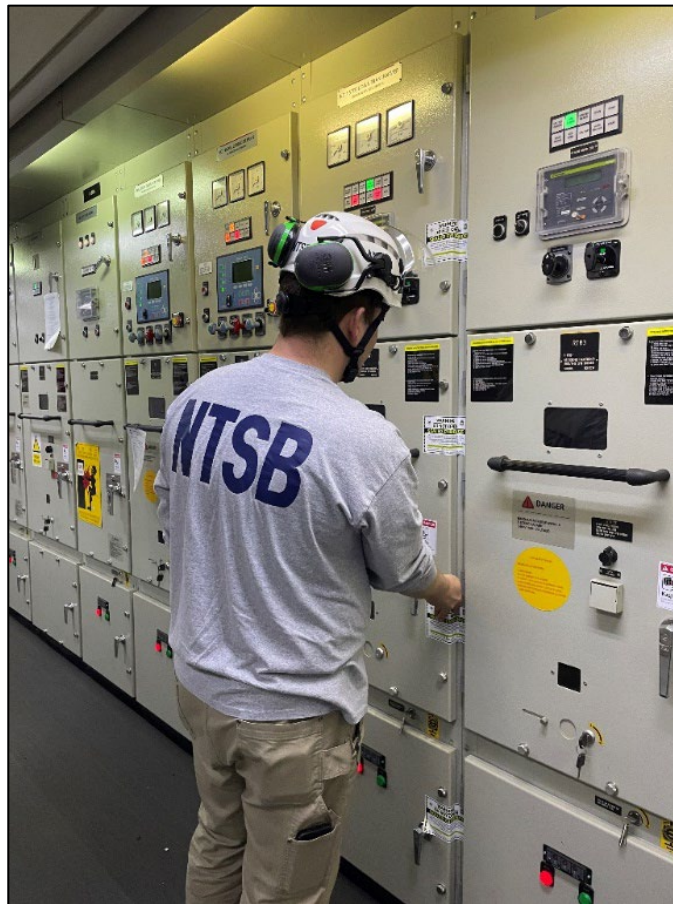
The *Dali* was equipped with an integrated control and monitoring system (ICMS) that retained information related to machinery and system changes and resulting alarms, including vessel engines and the electrical power management system. The NTSB has managed testing of the vessel's HV electrical bus and its components (including the HV and LV breakers) as the investigation parties and the electrical bus manufacturer, HD Hyundai Heavy Industries, Co. Ltd., work to identify the cause(s) of the breakers unexpectedly opening while approaching the Key Bridge and the subsequent blackouts (see figure 8).

Figure 8. An NTSB investigator examining the *Dali*'s HV switchboard (which houses the HV bus) and applying tamper-evident preservation seals.

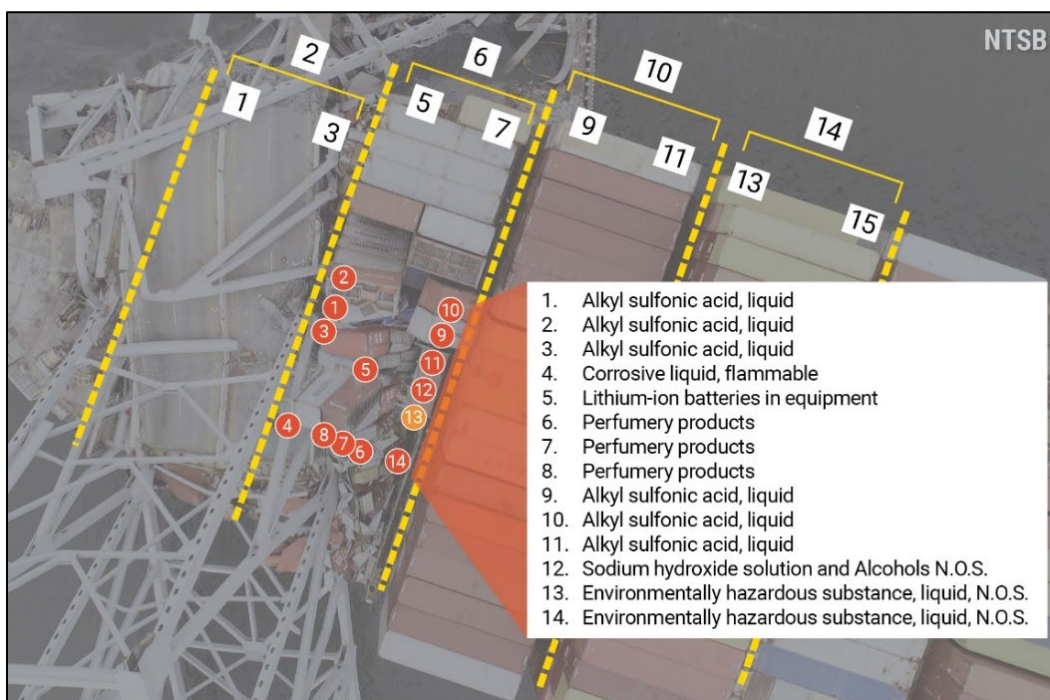
Of the 4,680 containers on board the vessel at the time of the accident, 56 were identified as containing dangerous goods (hazardous materials). The containers were located throughout the ship. The NTSB identified 14 containers, which were recorded as containing hazardous materials, that may have been damaged when the ship struck the Key Bridge or during the subsequent collapse of the bridge deck onto the ship (see figure 9 and table below). These 14 containers were all located forward of the superstructure, inboard in bays 5, 6, and 7.⁹

Figure 9. Approximate locations of cargo bays (yellow with numbers in white squares) and the 14 impacted hazardous materials shipping containers (orange circles with white numbers) transposed onto the *Dali* as seen after the accident. Hazardous material container no. 13 was in a portable tank, stored in the hold, below the deck.

atmospheric monitoring, and plugged the deck scuppers.¹¹ According to the Unified Command, no hazardous material from containers has reached the water. Salvors are transferring the bulk liquid acid to intact tanks and moving containers ashore.

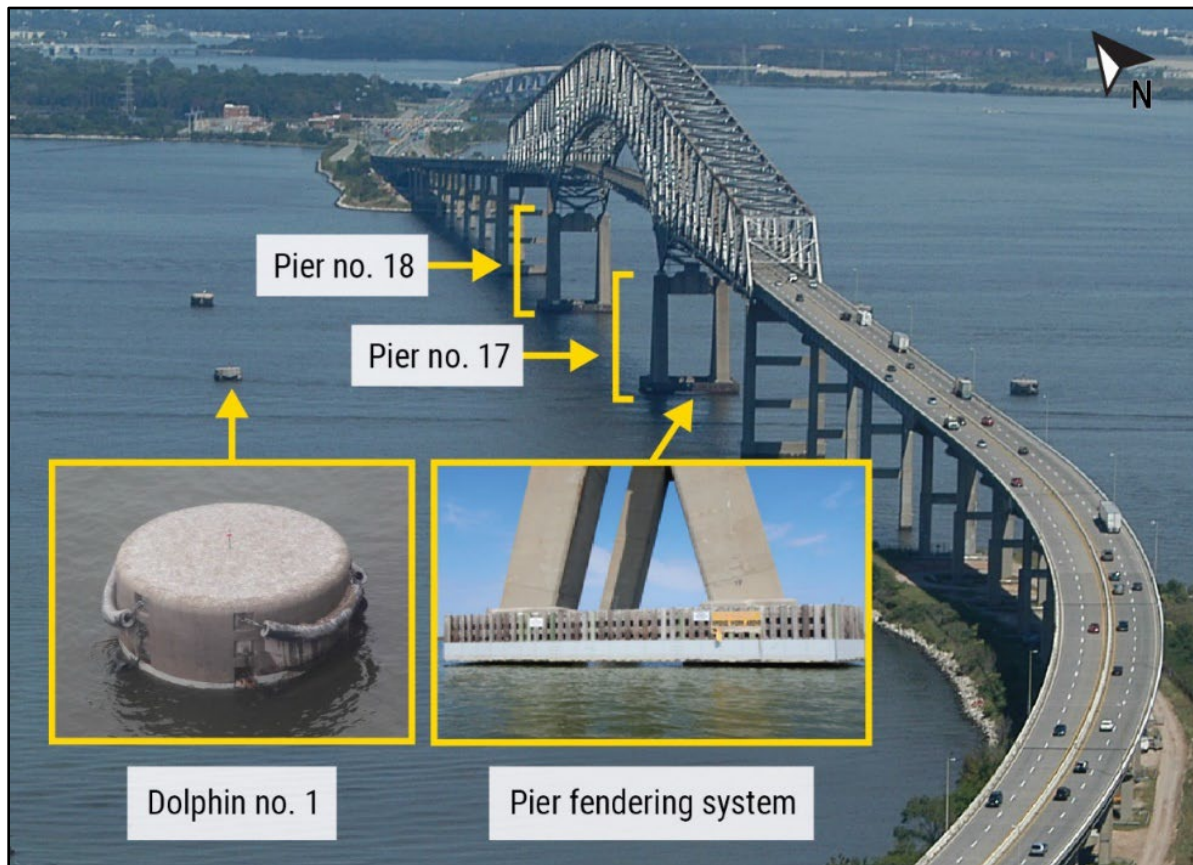
Figure 12. The Key Bridge and the locations of pier nos. 17 and 18. Insets show dolphin no. 1 as well as pier no. 17's fendering-system surrounding. (Background source: MDTA)

In addition to the dolphins, pier nos. 17 and 18 were each surrounded by a 100-foot-by-84.5-foot crushable concrete box and timber fender system, as seen in figure 12. These systems were comprised of hollow, thin-walled, concrete box structures attached to the piers. The timber portions of the fender were attached to the outer face of the concrete box and utilized a combination of vertical and horizontal members. Additionally, steel plates were secured at the base of the vertical timber members.

The *Dali* struck pier no. 17 and the fendering system surrounding the pier but did not contact dolphin no. 1 or its rubber fenders. Both fendering systems surrounding pier nos. 17 and 18 were further damaged during the collapse of the truss spans of the bridge when components of the truss spans impacted portions of the fenders as the components fell into the water.
