Interim report on the investigation of the collision between the container ship *Solong* and the oil/chemical tanker *Stena Immaculate*, resulting in one fatality, 14 nautical miles north-east of Spurn Head at the entrance to the Humber Estuary, England, on 10 March 2025

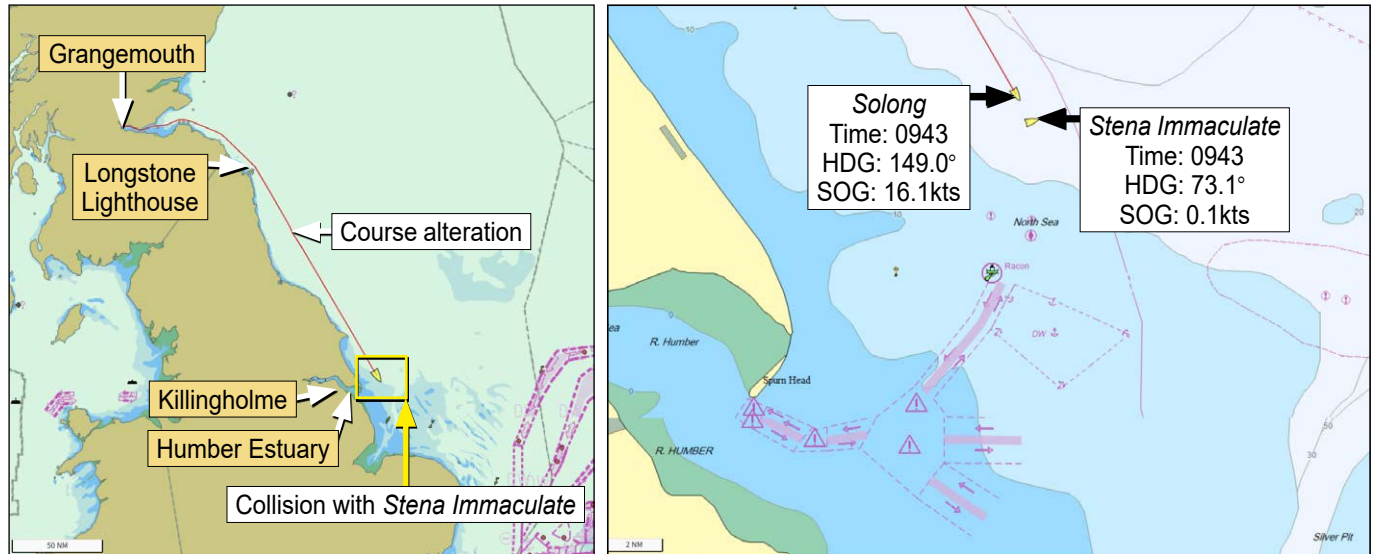
Figure 3: Passage of *Solong* and collision area

At 0947, *Solong* collided with the anchored *Stena Immaculate*'s port side on a heading (HDG) of 150° and speed over the ground (SOG) of about 16 knots (kts) (**Figure 3**). Able seaman Mark Pernia, one of *Solong*'s crew, was reported to be in the forecastle area at the time of the collision.

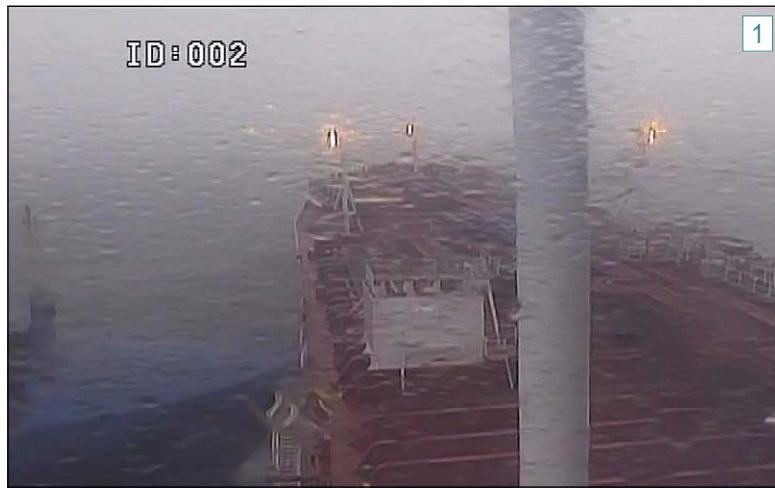
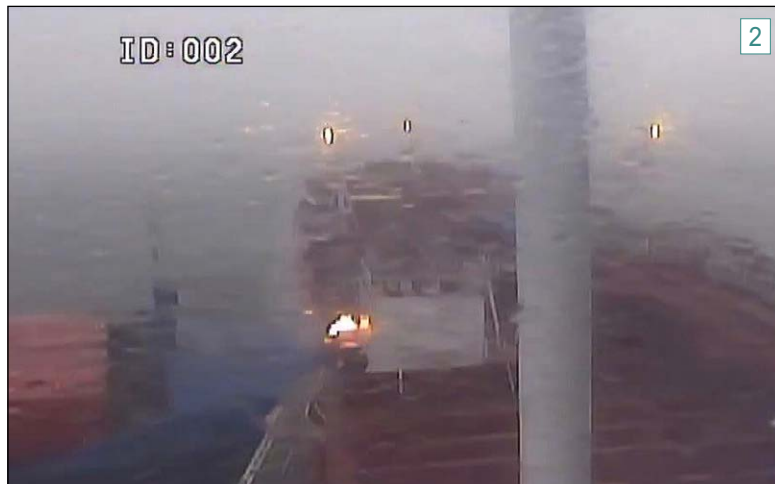
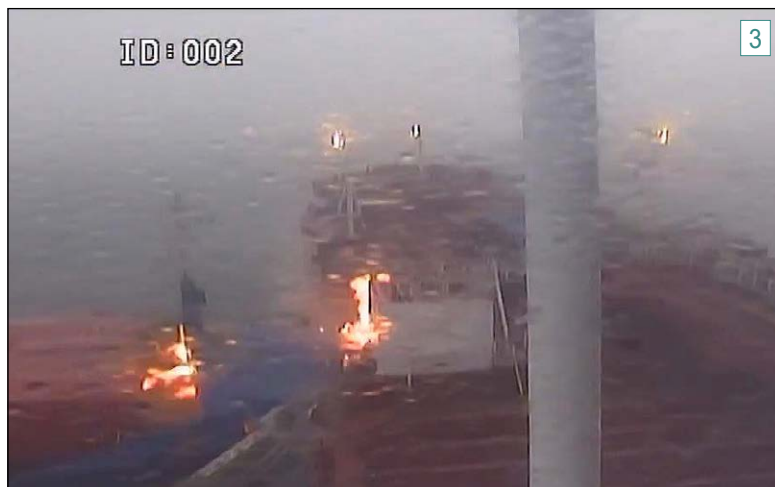
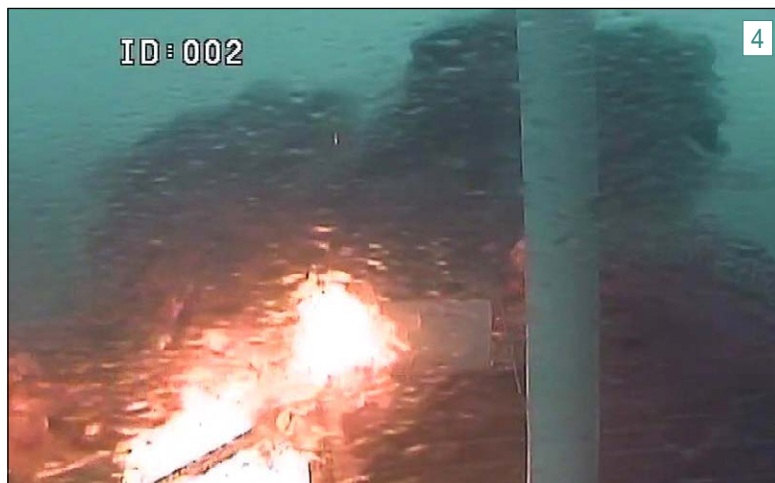
Figure 4: Initial collision

The collision breached *Stena Immaculate*'s No.7 port cargo tank, releasing aviation fuel into the sea and onto the bow of *Solong*. The aviation fuel was ignited by the heat generated by the force of the collision (**Figure 4**) and the resulting fire ignited the contents of containers carried on board *Solong*.
