Marine Investigation Preliminary Report

Contact of Containership *Dali* with the Francis Scott Key Bridge and Subsequent Bridge Collapse

Location:	Baltimore, Maryland	Accident Number:	DCA24MM031
Date and Time:	March 26, 2024 0129 local time (eastern daylight time)	IMO Number:	9697428
Ship:	<i>Dali</i> (Neo-Panamax containership)	Injuries:	8 (6 fatal)

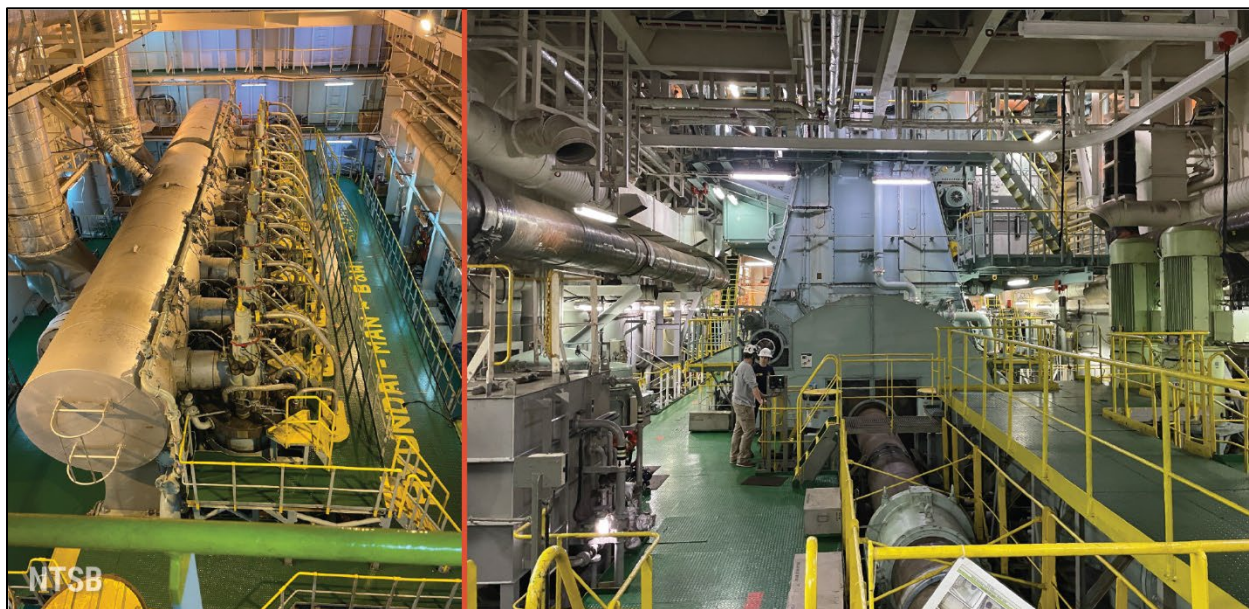
The *Dali* was propelled by a single, slow-speed, 55,626-hp (41,480-kW) diesel engine manufactured by Hyundai MAN B&W (see figure 2). The engine was directly connected to a single, right-turning propeller.

Figure 2. Left: The *Dali*'s main engine room (looking aft), showing the vessel's engine. Right: NTSB investigators examining the lower level of the vessel's engine room (looking forward).

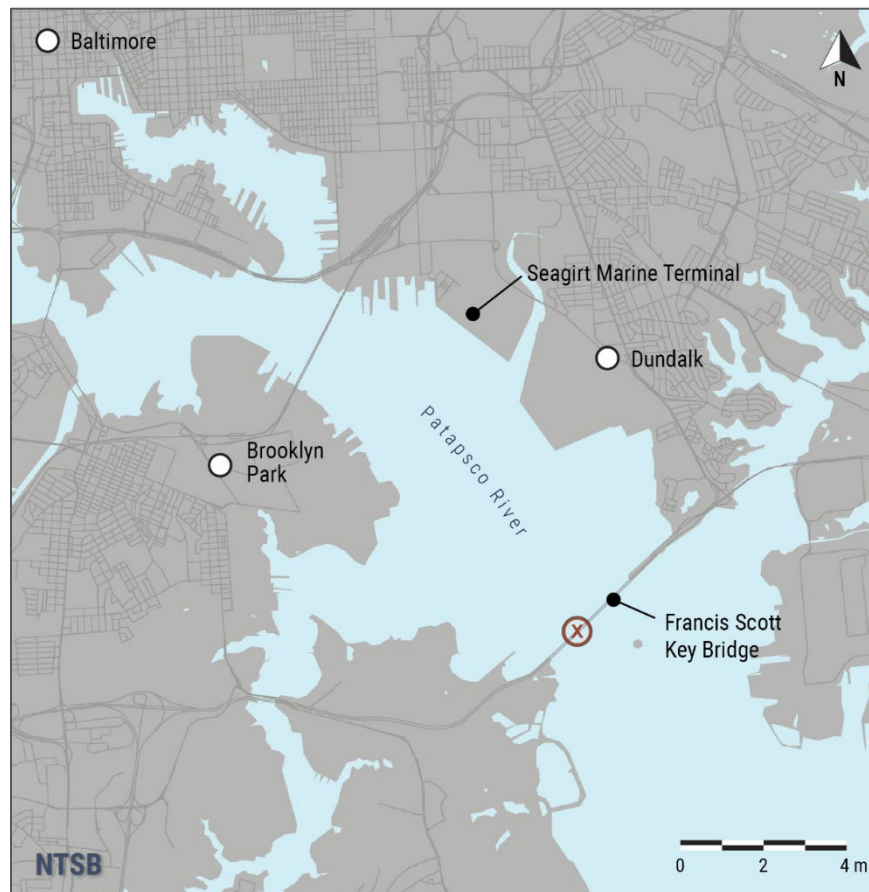
The following timeline depicts the events that occurred in the time leading up to the *Dali* striking pier no. 17 of the Key Bridge, the bridge's subsequent collapse, and initial search and rescue and recovery efforts for the road maintenance crewmembers (see figure 4).

Figure 4. Area where the *Dali* struck the Key Bridge, as indicated by the red X. (Background source: Google Maps)

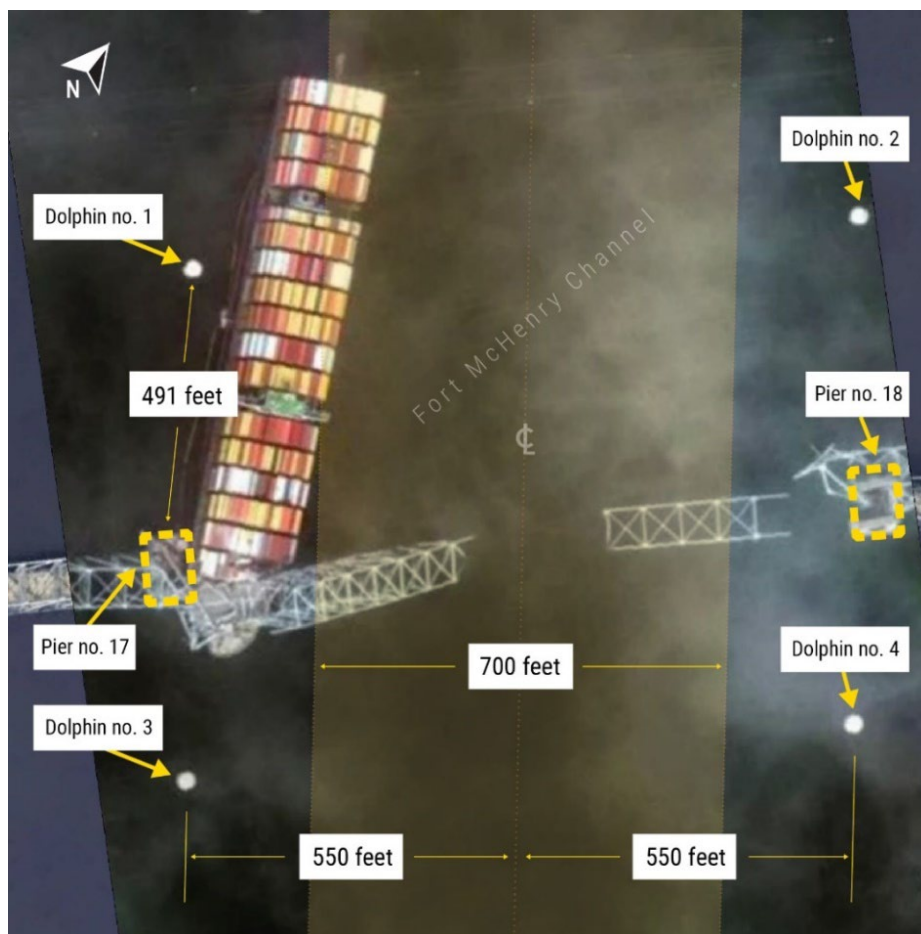
When the Key Bridge was constructed, four large dolphins—two located on the west side of the bridge and two located on the east side of the bridge—were also constructed at the same time to protect pier nos. 17 and 18 supporting the bridge’s central through-truss spans. Dolphin no. 1 was about 491 feet west of the center of pier no. 17 and 550 feet clear of the centerline of the navigational channel (see figure 11). The dolphins were constructed with a 25-foot-diameter sheet pile filled with tremie concrete and capped with reinforced concrete (see figure 12). Attached at various locations on the dolphin were 17-foot-long rubber fenders.

Figure 11. Locations of dolphins relative to the *Dali*, the Key Bridge, and Fort McHenry Channel. (Background sources: MAXAR and Google Earth)
