**IN THE UNITED STATES DISTRICT COURT  
FOR THE DISTRICT OF MARYLAND**

**GRACE OCEAN PRIVATE LIMITED,  
as Owner of the M/V DALI,**

**Civil Action No. 1:24-cv-00941**

**UNITED STATES' CLAIM AND ANSWER TO PETITIONERS  
GRACE OCEAN PRIVATE LIMITED AND SYNERGY MARINE PTE LTD'S  
PETITION FOR EXONERATION FROM OR LIMITATION OF LIABILITY**

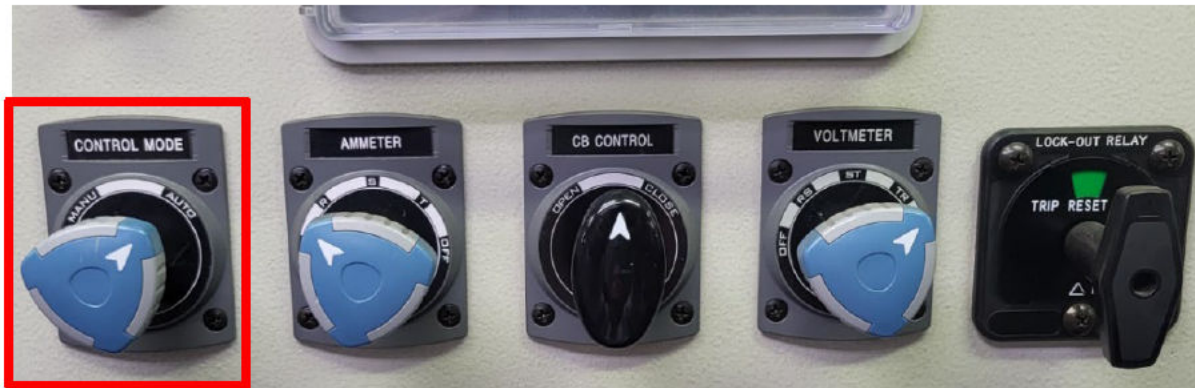
68. When in the automatic mode, if there is a loss of power through one of the step-down transformers, then the electrical system automatically transfers power to the other step-down transformer. Automatic transfer does not require crew intervention and results in the restoration of electrical power to the ship in a small number of seconds.

69. In contrast, when in manual mode, if there is a loss of power through one of the step-down transformers, the DALI's crew must manually transfer electrical power to the other step-down transformer—while in the darkness of a power outage.

*Step-down transformer controls, with the Auto/Manual Control Mode selector at far left. This photograph was taken post-accident.*

107. The inexplicable failure to use the “automatic” control mode on the step-down transformers rendered the DALI unseaworthy under the circumstances and was caused by Petitioners’ mismanagement of the ship and failure to properly instruct or train the crew. *See, e.g., In re Hercules Carriers, Inc.*, 566 F. Supp. 962, 976 (M.D. Fla. 1983) (“A shipowner has a non-delegable duty to provide a competent master and crew and to insure that its vessel is seaworthy so that any loss occurring by reason of fault or neglect in these particulars is within the privity and knowledge of the shipowner.”).

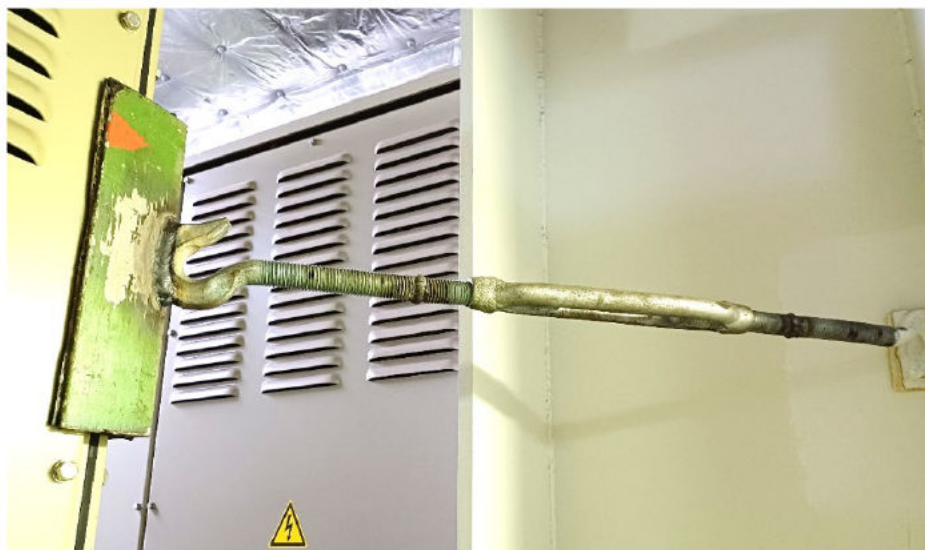
75. The DALI also had a vibration dampening rod wedged between the number 1 step-down transformer and a steel beam in the transformer room. It was jury-rigged, in the literal sense, from spare cargo equipment and painted white on one end. The anti-vibration rod is an after-market modification, not original to the build of the ship.

*Cargo chain turnbuckle, welded to angle iron, and wedged between the number 1 step-down transformer (left) and a steel beam (right).*

76. Problems obviously persisted after the rod's installation, since the steel bracket atop the number 1 step-down transformer cracked again.
